## HHSRS Report

1 Abc Street, London, N1 3EA

**Report Completed On:** 01/02/2019 00:00  
**Report Completed By:** Joseph Thompson / XYZ Lettings

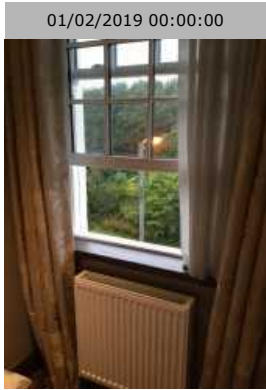
<b>Vulnerable age:</b>	Persons aged under 5 years
<b>Related hazards:</b>	Entrapment and collision
<b>Multiple locations:</b>	Yes
<b>Secondary hazards:</b>	Yes
<b>Description of hazards:</b>	<p>The Landing Balustrade: This is some 900 mm high and comprises 3 horizontal planks spanning between the top newel post and end post and has continuous horizontal gaps over 200 mm high between. From the landing there is a maximum free fall of some 2 metres to the bottom treads.</p> <p>Front and rear first floor windows: Both the front and rear bedrooms windows have a large opening, with no safety catch. Both have sills some 850 mm high with radiators below and are some 3.6 m above the ground, which comprises respectively a path and patio of concrete slabs.</p>

Likelihood/Outcome	A	B	C	Photos
1) Type of opening light	- Satisfactory, N/A	3 Seriously defective	- Satisfactory, N/A	
b) Safety catches	- Satisfactory, N/A	3 Seriously defective	- Satisfactory, N/A	
c) Opening limiters	- Satisfactory, N/A	3 Seriously defective	- Satisfactory, N/A

Fixing further planks to the landing ballustrade to fill the gaps and make climbing difficult and fitting safety catches on the first floor front and rear windows, would reduce the overall risk of a fall substantially. Removing the concrete slabs immediately below the window and planting bushes would improve the overall spread of harms but less so.

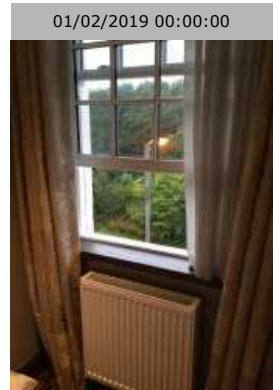
d) Sill heights	- Satisfactory, N/A	1 Not satisfactory	- Satisfactory, N/A	
f) Ease of cleaning	- Satisfactory, N/A	3 Seriously defective	- Satisfactory, N/A	
h) Easily climbed guarding etc	3 Seriously defective	- Satisfactory, N/A	- Satisfactory, N/A

i) Openings in guarding      3 Seriously defective      - Satisfactory, N/A      - Satisfactory, N/A
