Landlord Maintenance Report

3 ABC Street, London, N1 3EA

Report Completed On: 10/03/2015 23:59

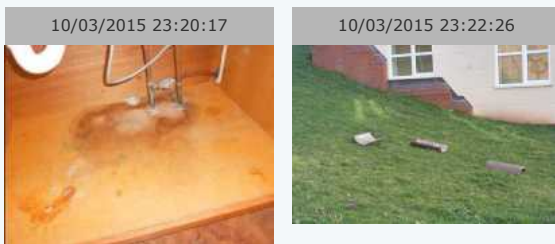
1. Kitchen - obvious signs of water damage to unit below sink, recommend urgent repair (see photo)
2. Exterior - roof - 3 ridge tiles fallen in high winds, recommend urgent repair (see photo)

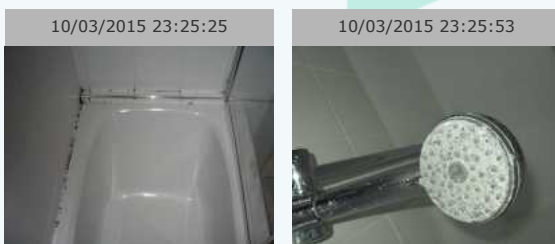
1. Bathroom - bath sealant with extensive mildew spots, recommend replace (see photo)
2. Bathroom - shower head limescaled, recommend replacement (see photo)
